Ammonium nitrate induced cracking of a dryer.

R.E.Clegg^{1§}, R.Tomlins² and M.J.Mackay³

Abstract

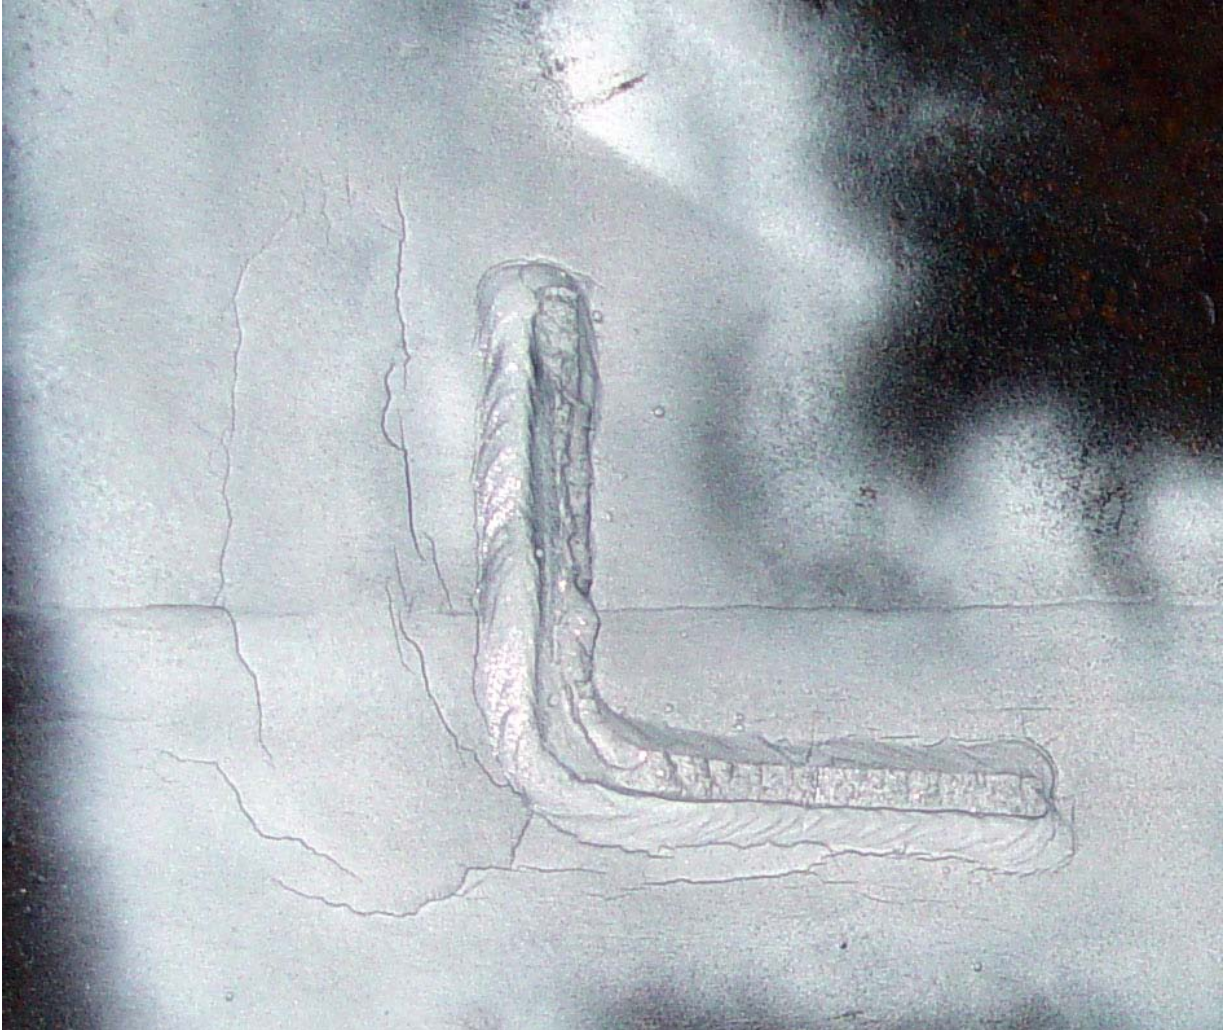
Cracking of the dryer shell was generally associated with welds or in several cases, where welds had been removed. Cracking of the lugs was generally either in the toe of the welds or transverse to the welds (see Figure 1). Cracking was also found associated with the circumferential and longitudinal welds in the shell (see Figure 3). In some cases, the cracks penetrated the thickness of the shell. The cracks were predominantly transverse to the welds and often were confined to the weld metal. However, in a number of cases, the cracks were found predominantly in the parent plate.

Figure 1 Extensive cracking around the welded lugs and in the welds could be seen on the inside of the shell.

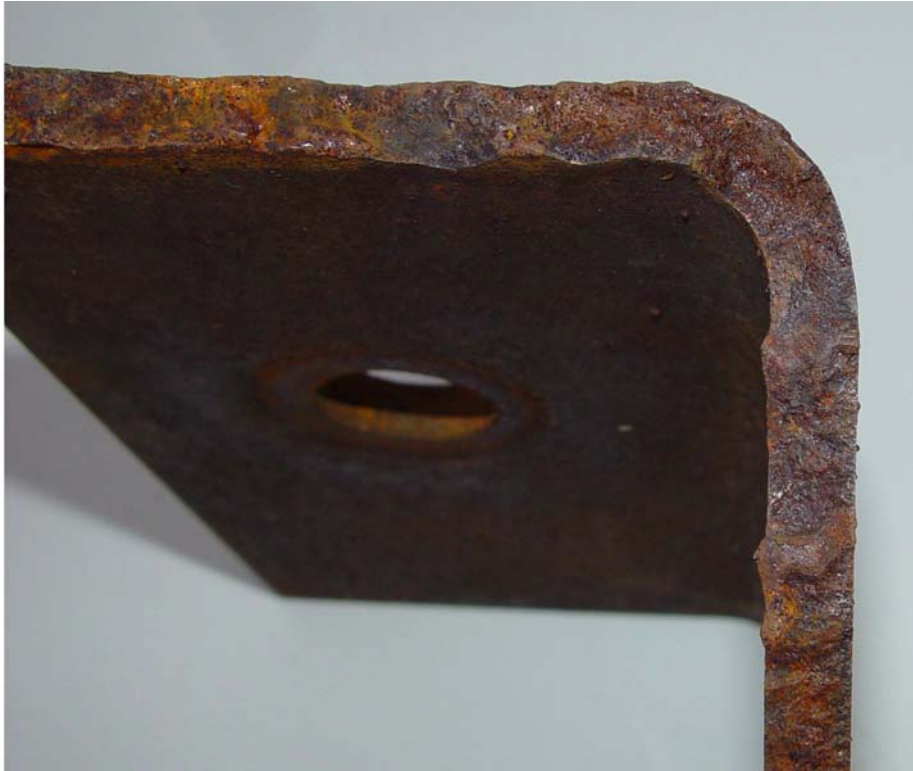
Each of the internal lifters was attached to the shell by bolting to two welded lugs. In a number of cases, these lugs had fractured through the heat affected zones of the welds. Failure of the lugs had occurred in the region of the welds, predominantly in the HAZ (see Figure 2). The

fracture showed little ductility, although it was covered with a layer of corrosion product. The fracture did not appear to be a fatigue failure and the fracture surface was textured in a manner consistent with stress corrosion cracking.

Figure 2 Lifter showing the cracked lugs. These lugs had been welded to the shell and had fractured through the HAZ of the weld.

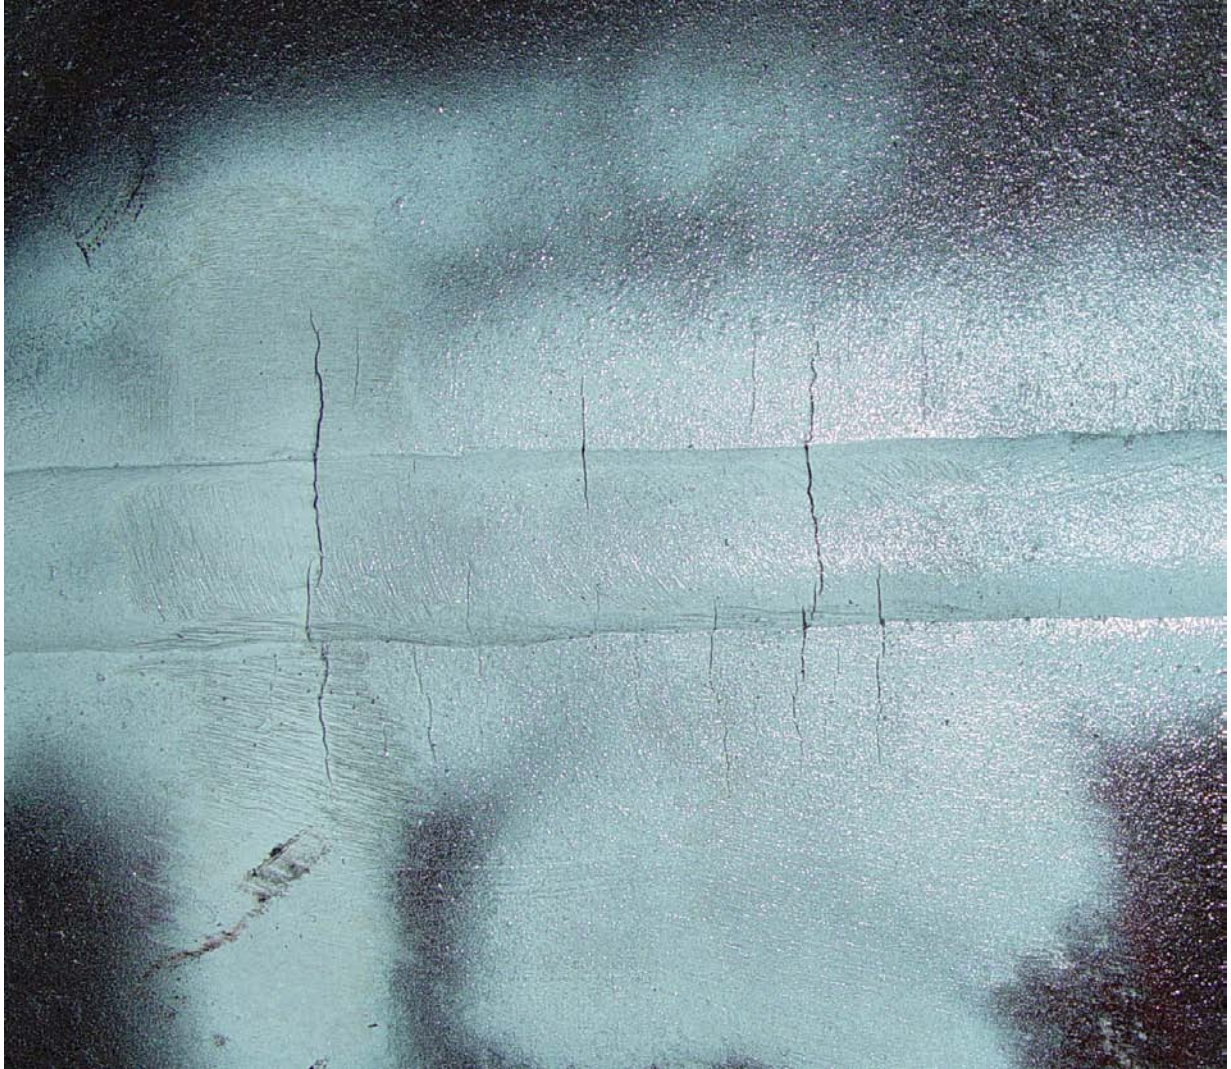
A 200 mm diameter circular test section containing a longitudinal weld was cut from the shell of the dryer. Several large transverse cracks (approximately 50 mm) were found in the weld metal and these cracks extended into the parent metal. In addition, a number of cracks that were smaller in size but entirely confined to the parent metal were also found. Metallographic sections of a weld metal crack and one of the smaller non-weld metal cracks were taken.

Figure 3 Transverse cracking in seam welds.

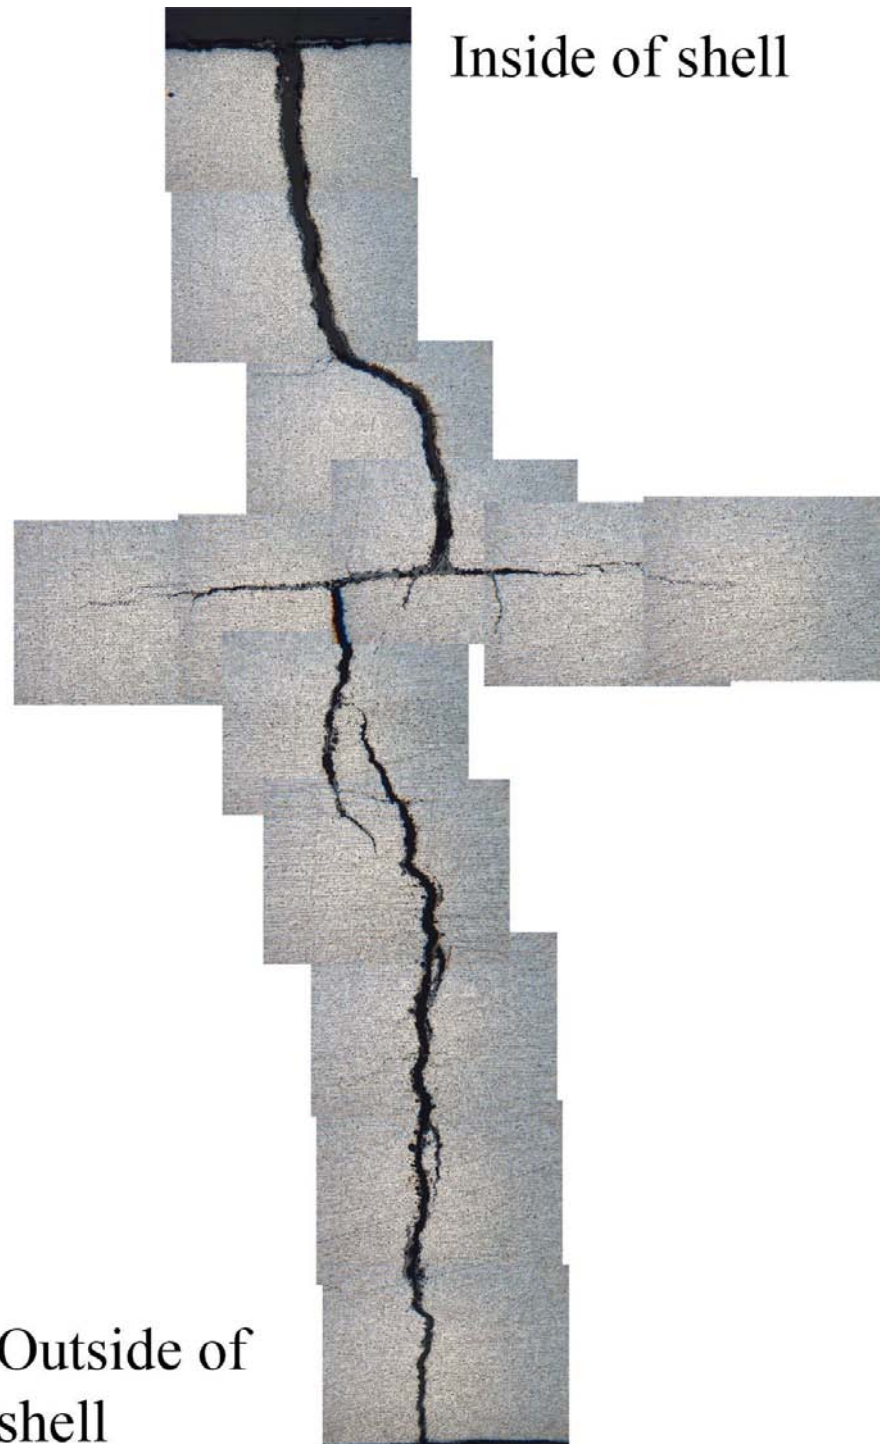
The parent plate consisted of pearlite and ferrite. In the section examined, the crack had penetrated from the inside surface of the shell to the outside surface. In places the crack had branched and ran parallel to the plane of the plate. This was particularly noticeable near the centreline of the plate. Cracking was generally intergranular in nature and were commonly

filled with oxide. A number of fine intergranular cracks could be seen propagating from the inside surface of the shell (Figure 4). The inside surface also showed evidence of general corrosion and some intergranular attack (Figure 5).

Figure 4 Cracking of the shell occurred from the inside to the outside of the shell. Significant centreline cracking was observed.

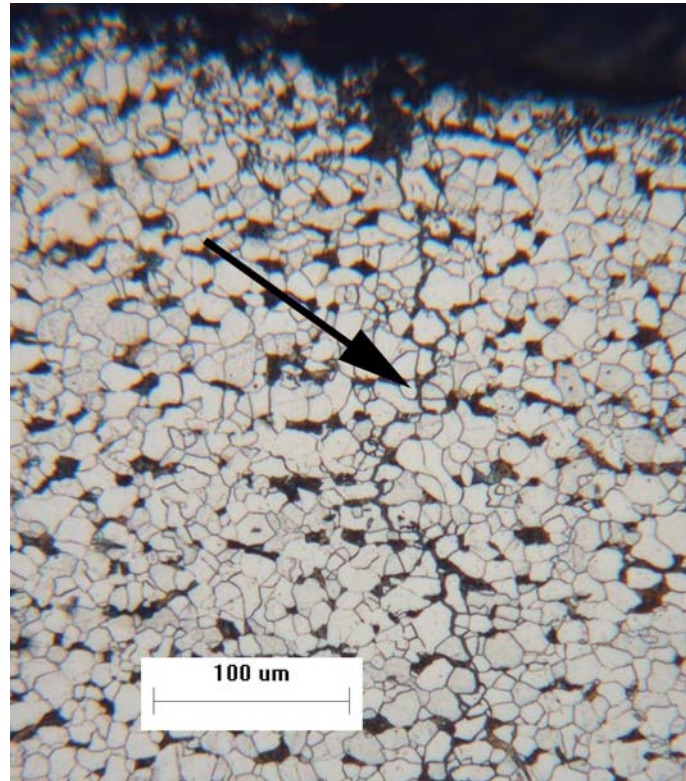
Figure 5 Small crack coming from the surface of the steel plate.
