REVIEW OF HARD/SOFT METHODS OF BEACH PROTECTION THE CAPRICORN COAST CASE STUDY.

James Goldston Faculty of Engineering and Physical Systems
Central Queensland University
Email: j.piorewicz@cqu.edu.au

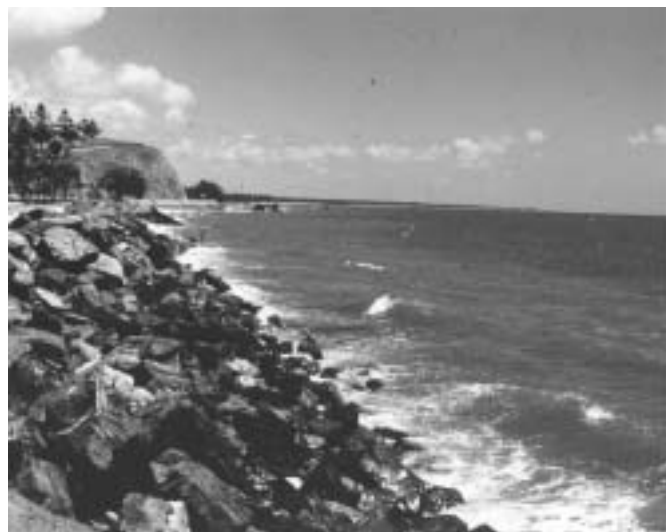
Sea-walls and/or bulkhead are the massive structures built parallel to the coastline to prevent the cross-shore transport of material from the coast towards deeper water (Figure 6). They can be an appropriate counter-measure to prevent unwanted erosion due to a single occurrence of a storm surge; however, they do not diminish at all the retreat of the dunes above the highest level of the defence.

Figure 6. Bulkhead on Yeppoon Main Beach at High Water

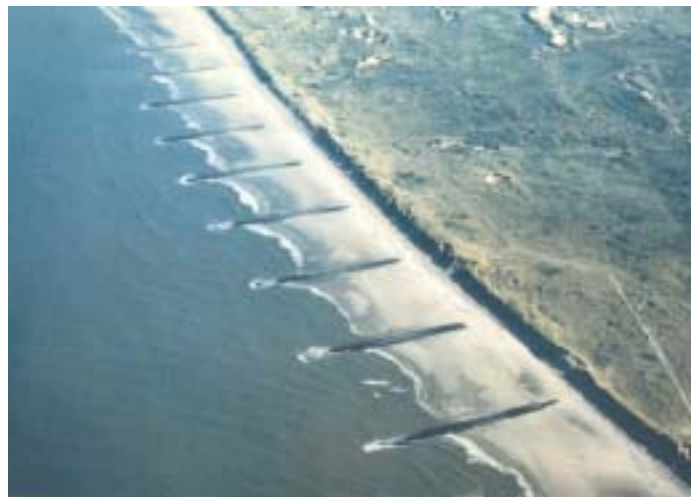
Groynes have been installed across the path of littoral drift in order to retain beaches where they have been needed. The groynes must extend through the breaker zone and have crests above the still water level to be completely effective (Figure 8). The area protected by the groins will not erode but will interrupt the longshore drift. Therefore severe erosion will result down drift of the last groyne (Figure 9). The groynes simply displace the erosion problem. Still the groynes functional behaviour is the least understood.

Figure 8. Example of groynes application in Holland

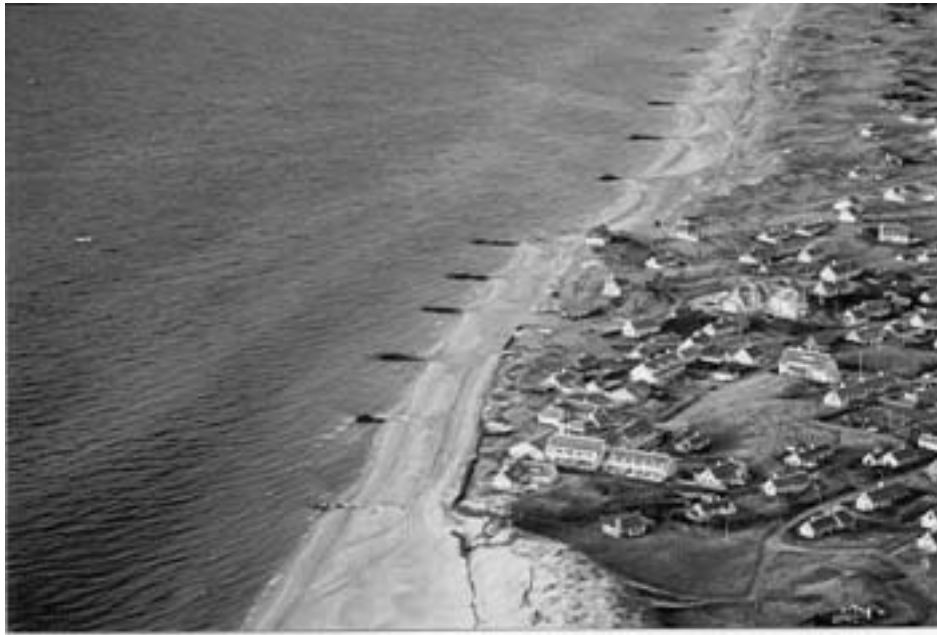
- Pressure Equalisation Modules patented by S/C Skagen Innovation Centre, Denmark. They advertise effectiveness of their method almost in every condition. An example is shown in Figure 17 and 18 taken from their web site (www.skagen-innovation.dk)

Figure 17. Aerial photo of the groynes at Gl. Skagen, before the implementation of pressure equalisation modules. (www.skagen-innovation.dk)

The later aerial photo (Figure 18) from 1999 illustrates very clearly that pressure equalisation modules are far more effective than the conventional groynes from 1950. As can be seen from the photo, these groynes are now completely covered by sand on the new and sustainable beach.

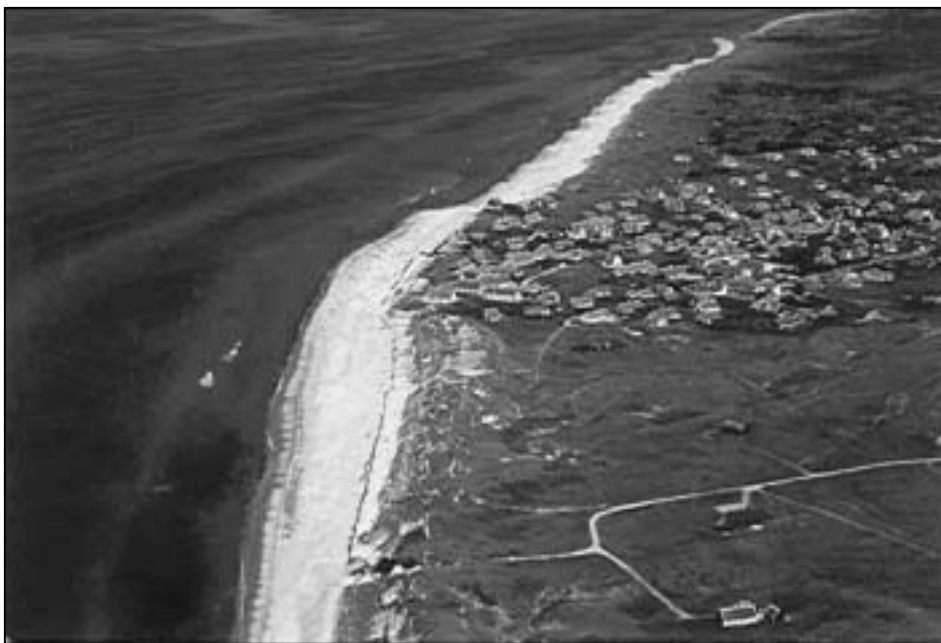
Figure 18. Aerial photo of the same location in 1999, 15 months after the implementation of pressure equalisation modules. (www.skagen-innovation.dk)

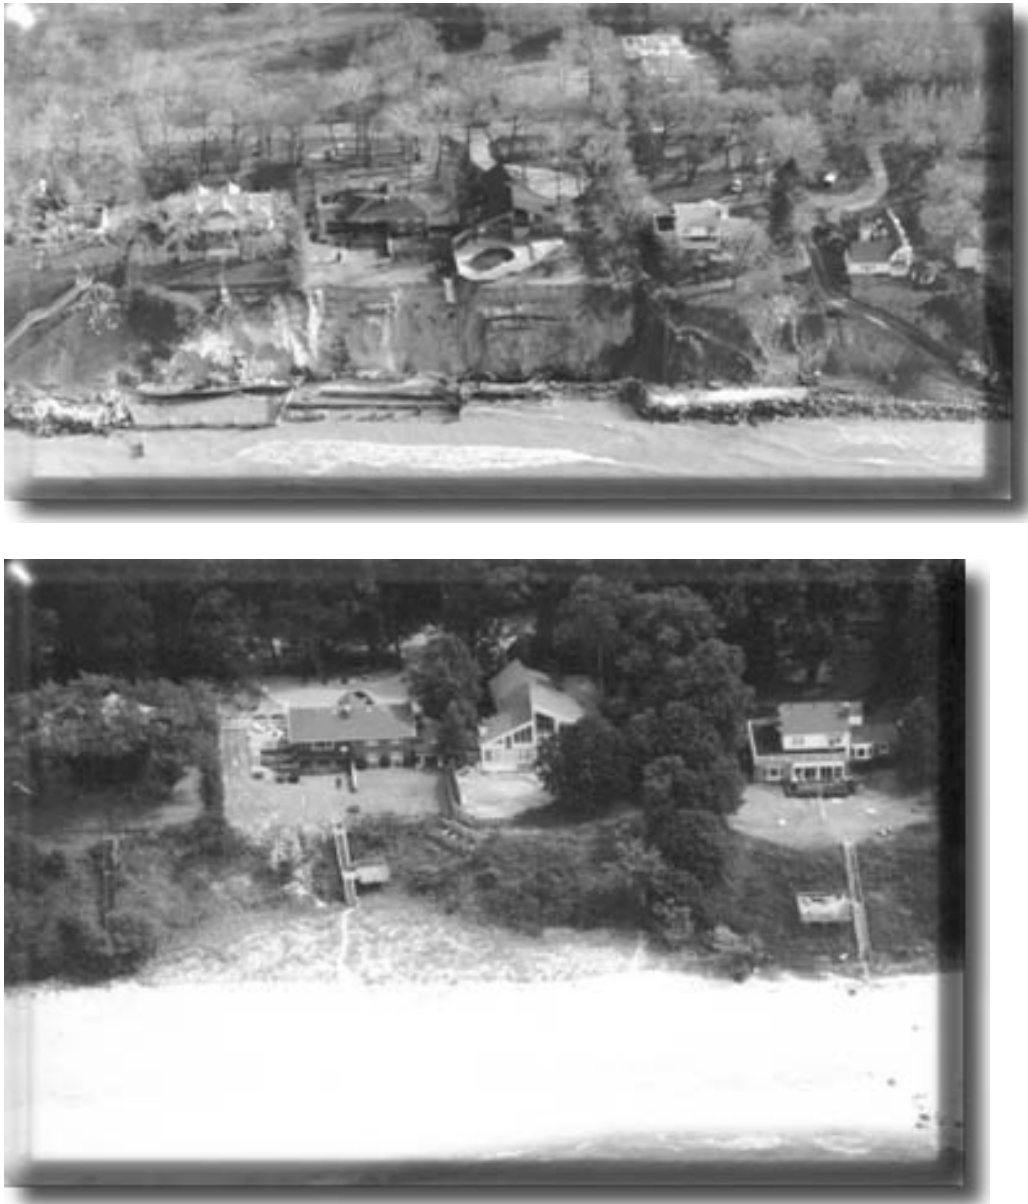
- Undercurrent stabilizers patented by Holmberg Technologies, USA. They are low profile geotextile tubes that run at right angles from dune or toe of the bluff, across the beach face to an appropriate distance offshore. As patented, no more general information is available. Some example of the effectiveness of their method is shown in Figure 19 (www.erosion.com/shore.html).

Figure 19. Example of undercurrent stabilizers application. (www.erosion.com/shore.html).

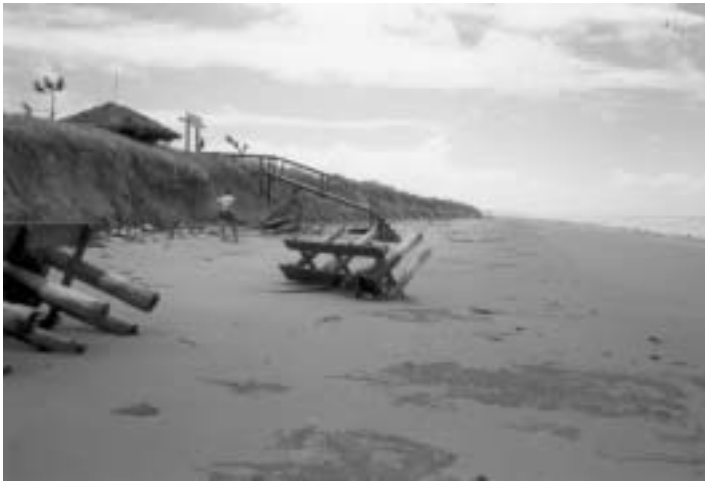
The Farnborough Beach, about 15 km long, exhibits extensive dune blowouts formations which have apparently been a more or less permanent features historically, allowing considerable vertical growth of dune heights. It represents a well established natural system of the dunes exposed to periodical erosion/sedimentation processes. In the region of the Capricorn International Resort erosion process in the years 1988-90 caused erosion up to 20 m. Since 1993, foredune redevelopment is clear and up to 30 m of foredune has been naturally rebuild. (Figures 22 and 23).

Figure 22. Farnborough beach near the Capricorn International Resort, situation in April 1989

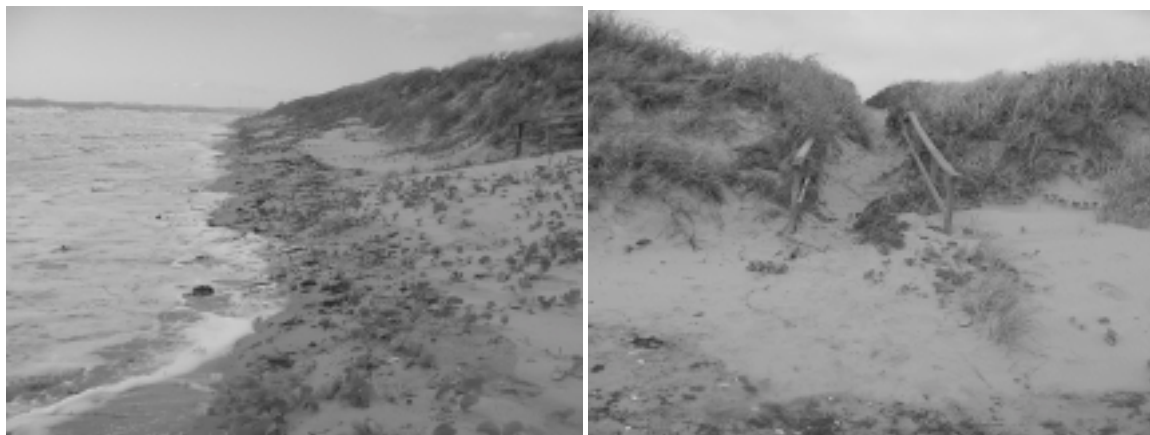
Figure 23. Farnborough beach near the Capricorn International Resort, situation in January 2002

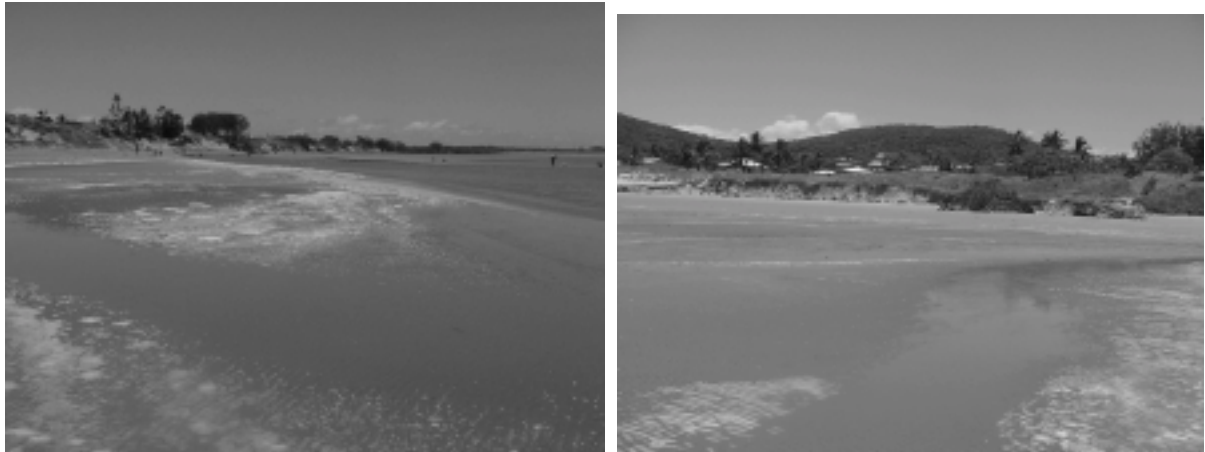
Bangalee area and further south towards Barwell Creek a new foredune ridge has been accreted in recent years, however, development adjacent to Barwell Creek is vulnerable to cyclonic erosion. In view of the general trend of accretion in the area no action had been considered so far. In the recent years the output from the Creek moved significantly southward, since 1989 for a distance of about 1000 m causing serious problem to the stability of the existing dunes (Figure 24). In the view of the progressing erosion in the last years some action connected with Barwell Creek stabilisation is required.

Figure 24. Farnborough beach near Barwell Creek, situation in January 2002.

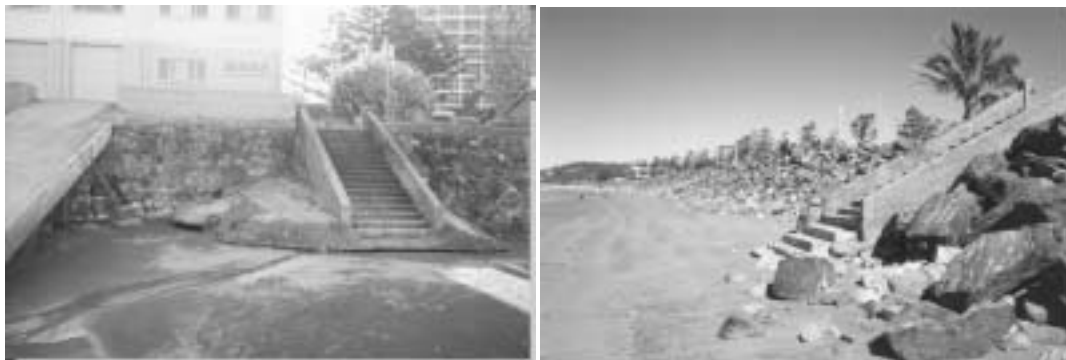
A seawall was constructed along most of Yeppoon Main Beach in the early 1930's and after being partly damaged by cyclonic wave attack in 1976, it was reconstructed and extended in the form of rubble mound rockwall (see Figure 6). In the light of BPA analysis, shown in Table 1, this reconstructed wall is inadequate to withstand severe cyclonic conditions. In early 1990's it was visible severe erosion of the beach causing some threatening to the stability of the existing seawall (Figure 25).

Figure 25. Erosion of the Yeppoon Main Beach, situation in early 1990's.

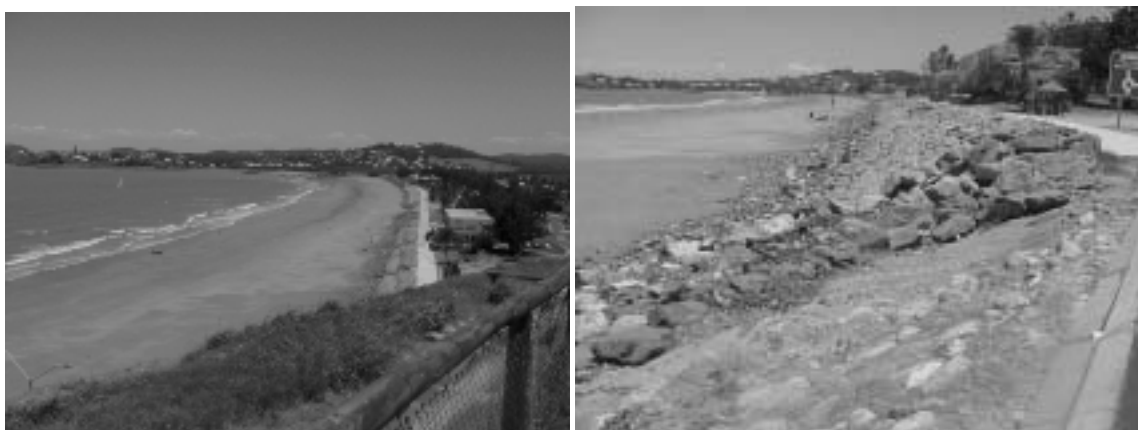
In 2001 additional reconstruction of seawall was conducted following BPA recommendation to strengthen the existing rockwall (Figure 26) before any works would be undertaken with the esplanade next to the beach for so called beautification of the Yeppoon recreation area.

Figure 26. Reconstructed rockwall on Yeppoon Main Beach, situation in January 2002

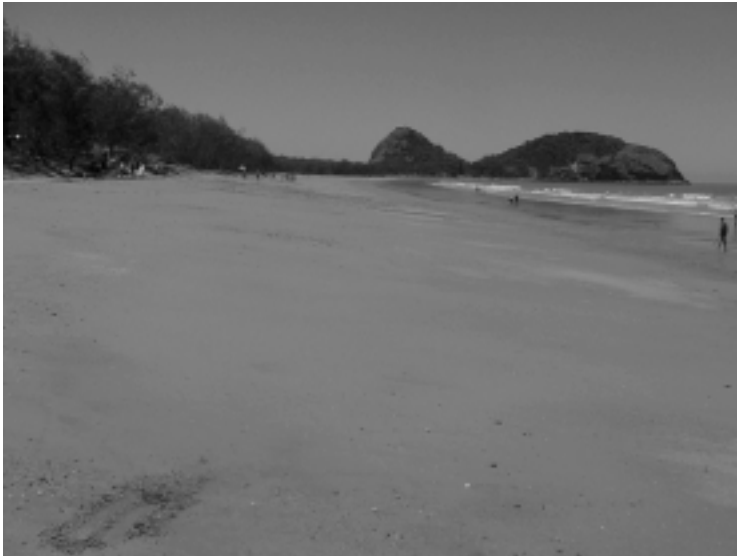
No serious erosion problems are evident at Kemp Beach and only a dune management program should be carried out to stabilise and protect foredune vegetation. (Figure 29).

Figure 29. Kemp Beach, situation in January 2002

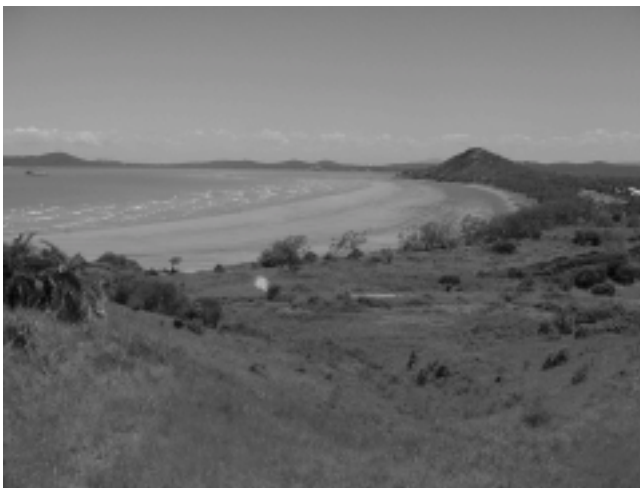
Because of the high level of stability provided to Mulambin beach by the adjacent headlands and the relatively strong onshore transport of sand from offshore, Mulambin Beach has not experienced any measurable erosion in the last 50 years (Figure 30).

Figure 30. Mulambin Beach, situation in January 2002

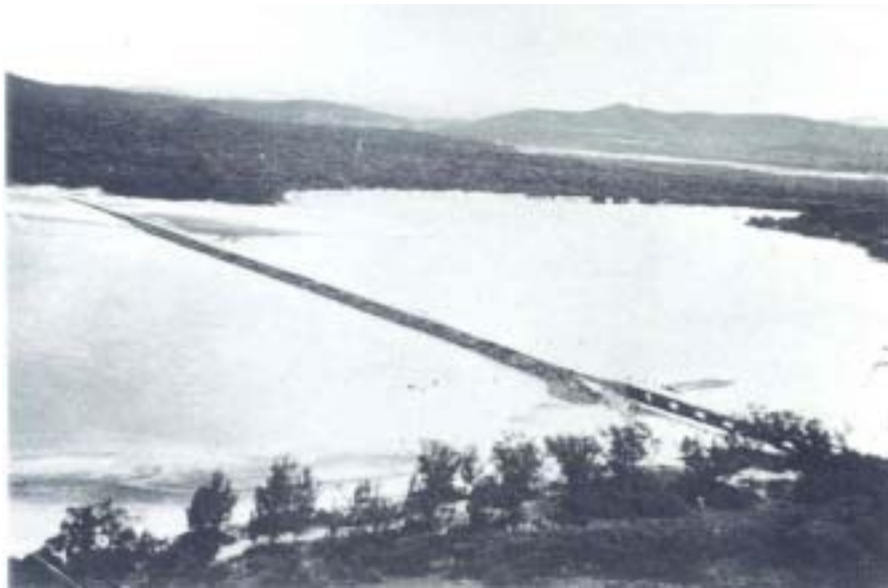
Figure 31. Causeway just after construction in September 1939

Significant changes have taken place along the Kinka beach, particularly in its north and central parts since a causeway was constructed across the Mulambin Creek estuary, adjacent to Pinnacle Point, in 1939 (Figure 31). Extensive erosion in the central beach area reduced the dune width from about 90 m to almost none in the period 1960 - 1985 in spite of rockwall construction. Such situation threatens local residents about possible erosion of the Yeppoon - Emu Park road, and their properties (Figures 32,33).

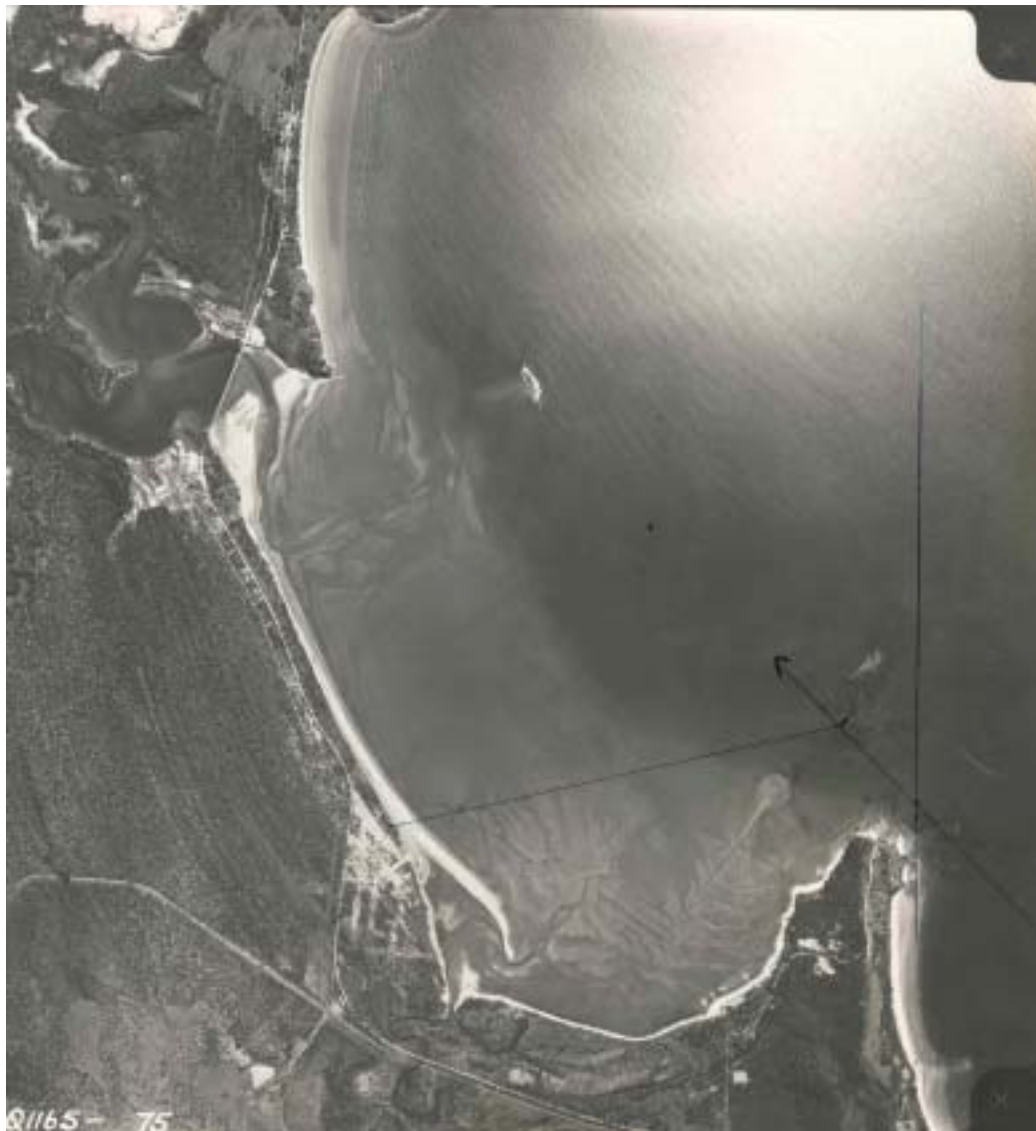
Figure 32 Aerial Photo August 1961

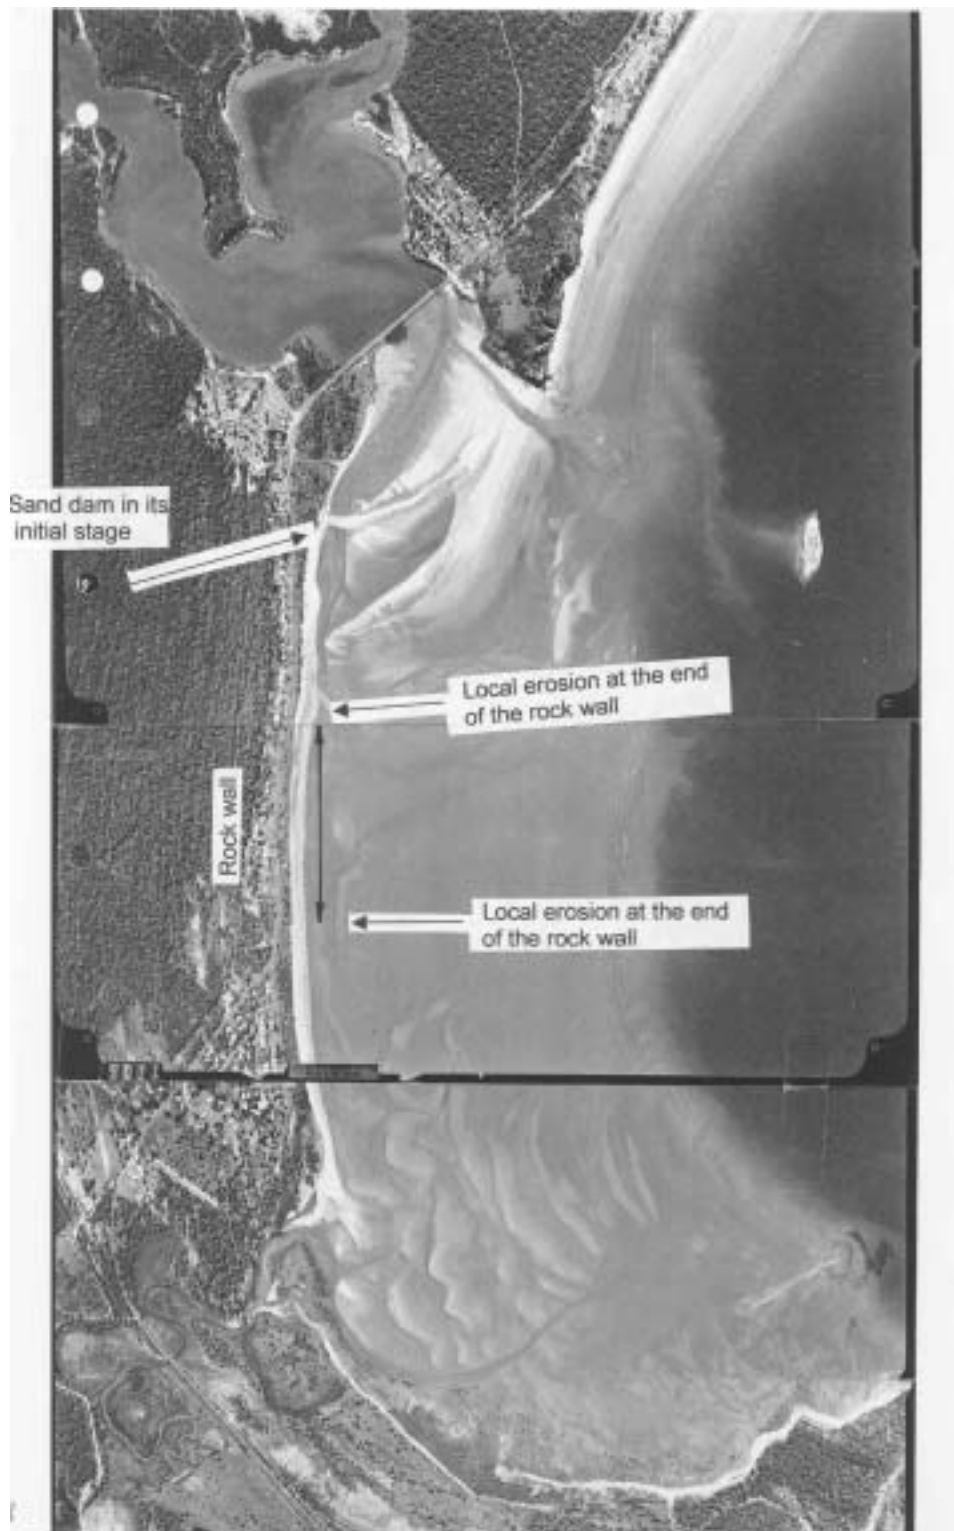
Figure 33. Aerial Photo May 1988

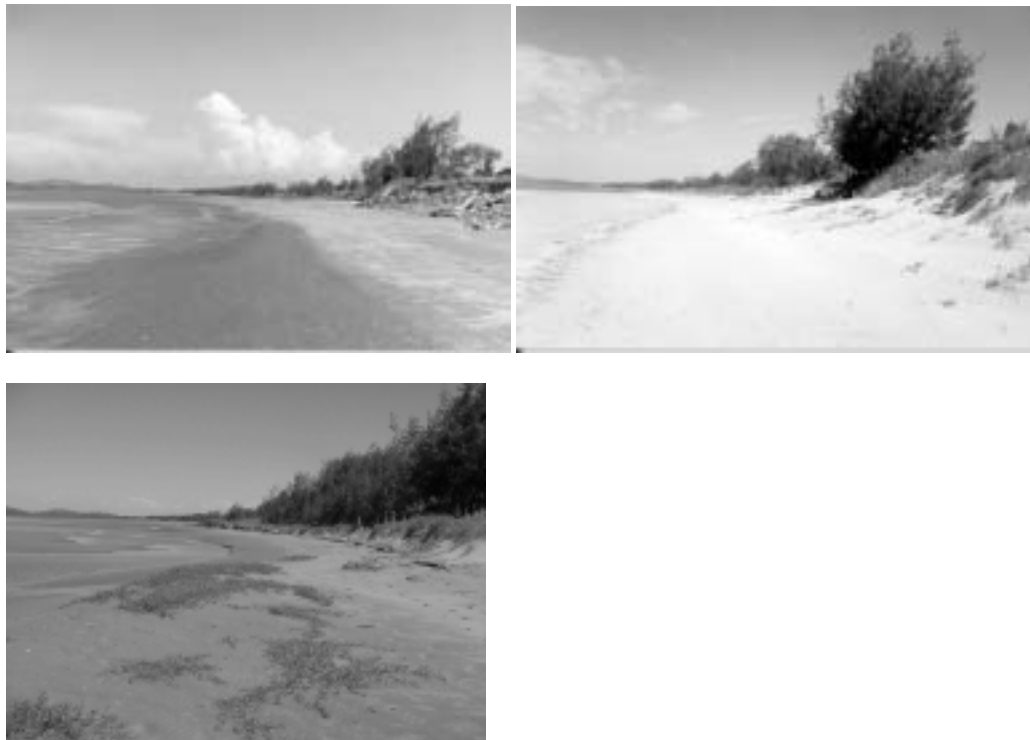
Before sand dam construction, the only used method of beach protection in this region was rock dumped directly on the dunes. This type of protection did not stop process of erosion, but only shifted it southward. The slow process of beach rebuilt started since the sand dam was constructed in 1988 with the visible and effective dune system improvement since 1993. Between 1993 and 1997, 80 percent of the rock wall was completely buried under the naturally accumulated sand and dunes get their natural shape and become covered with grass and shrubs. It is visible increase in dunes and dry beach (above MHWS mark) width (Figures 35, 36).

Figure 35. Improvement of Kinka Beach dune conditions for the period 1989 - 1998 - 2002

Figure 35 shows how the beach with initially strong erosion slowly return to its natural shape with dunes covered by greens. The process is still in progress. But it could be stopped if process of washing away the sand dam is not stopped. With not spending money for maintenance of the sand dam for the last 12 years it is now time to do it if one does not want that erosion problems on north Kinka Beach will come back.

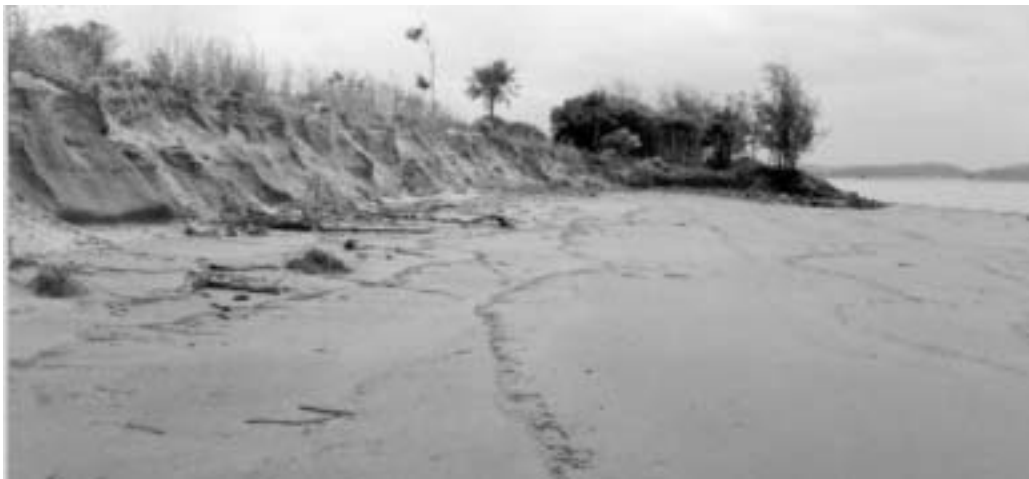
The southern part of Kinka Beach was not considered at this stage of study. However, it was found in continues erosion process. Particularly at the south end of the temporary rockwall local erosion become very critical in 1996 (Figure 37). Buried seawall, length of 280 m, as well as groyne made of geo-textile bags were implemented at the beginning 1998, as recommended by BPA. Buried seawall was constructed as a southward extension of the existing temporary rockwall in the area shown in Figure 37. Cross-section of buried sea-wall is shown in Figure 38. View of buried seawall just after construction and at present, in January 2002, is shown in Figure 39. Geo-textile groyne marked on Figure 36 is shown in Figure 40. The effect of implemented solution has been currently monitoring by CQU (Piorewicz, 2001).

Figure 37. Erosion on south end of Kinka beach, March 1996

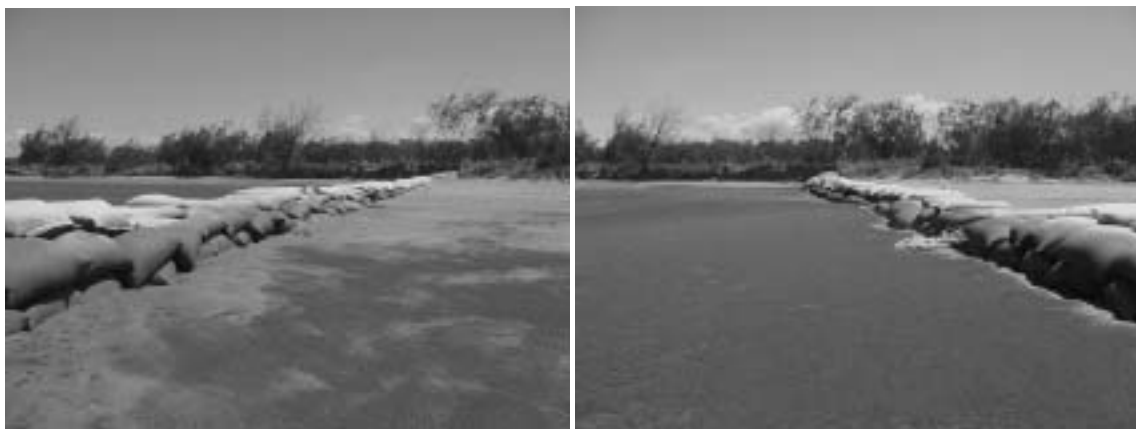
Figure 40. Geo-textile groyne on South Kinka, January 2002

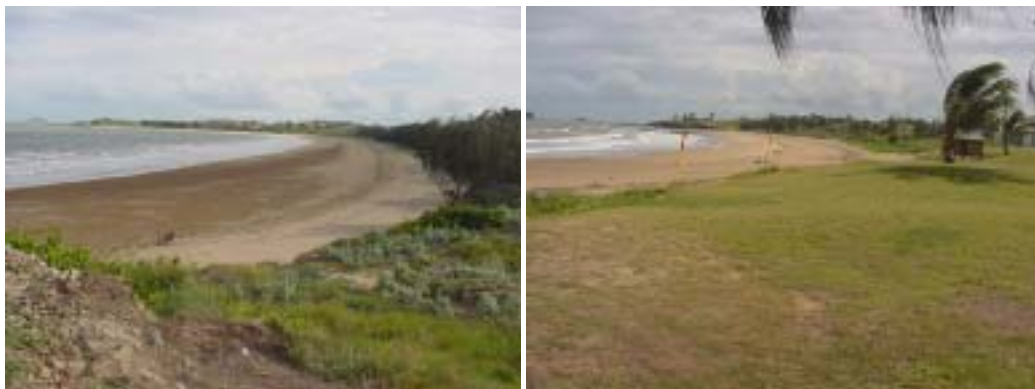
Erosion is not a problem along this section of the coast. At Emu Park the dune area is some 80 to 100 m wide and remains undeveloped and available for accommodate potential future erosion (Figure 41).

Figure 41. Emu Park beaches, January 2002

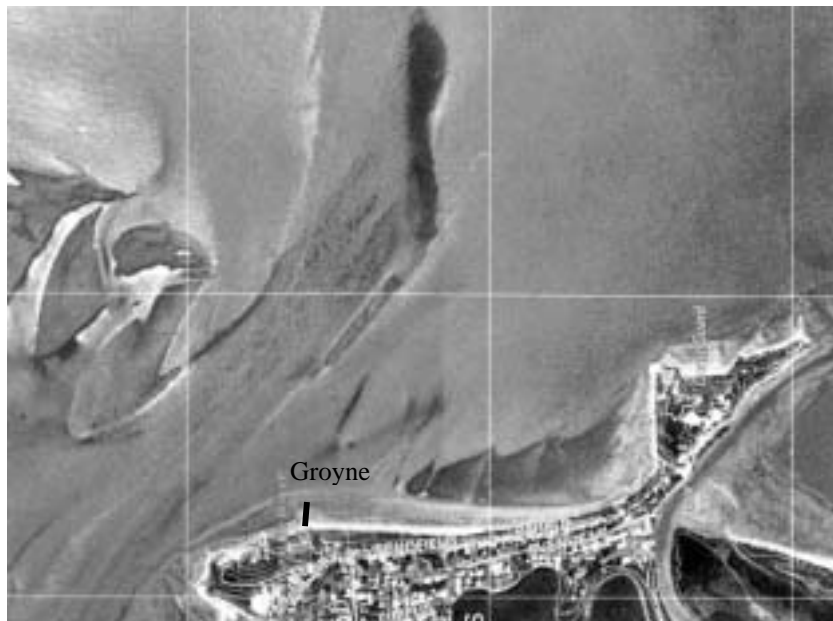
Figure 42. Aerial photo of Keppel Sands

Keppel Sands beach is vulnerable to erosion and temporary protection with rubble and sleeper rockwall has been inadequate to protect the dune if “design” storm happens. Very flat and wide (up to 1 km) intertidal zone, shown in Figure 42, causes that any option for beach protection is very expensive. Some study has been carried out by BPA and CQU to find economically and environmentally accepted solution to improve natural sedimentation in this area. The optimal solution suggested by CQU, in its recent study, was extension of the existing groyne for another 100 m, creating this way headland which should help to restore the beach (Figure 43). View of extended groyne is shown in Figure 44. Monitoring has been carried at present and some conclusion about this approach to the beach restoration should be expected at the end of this year. Particularly the conclusions about south site of the beach where rockwall is exposed to the wave action (Figure 45).

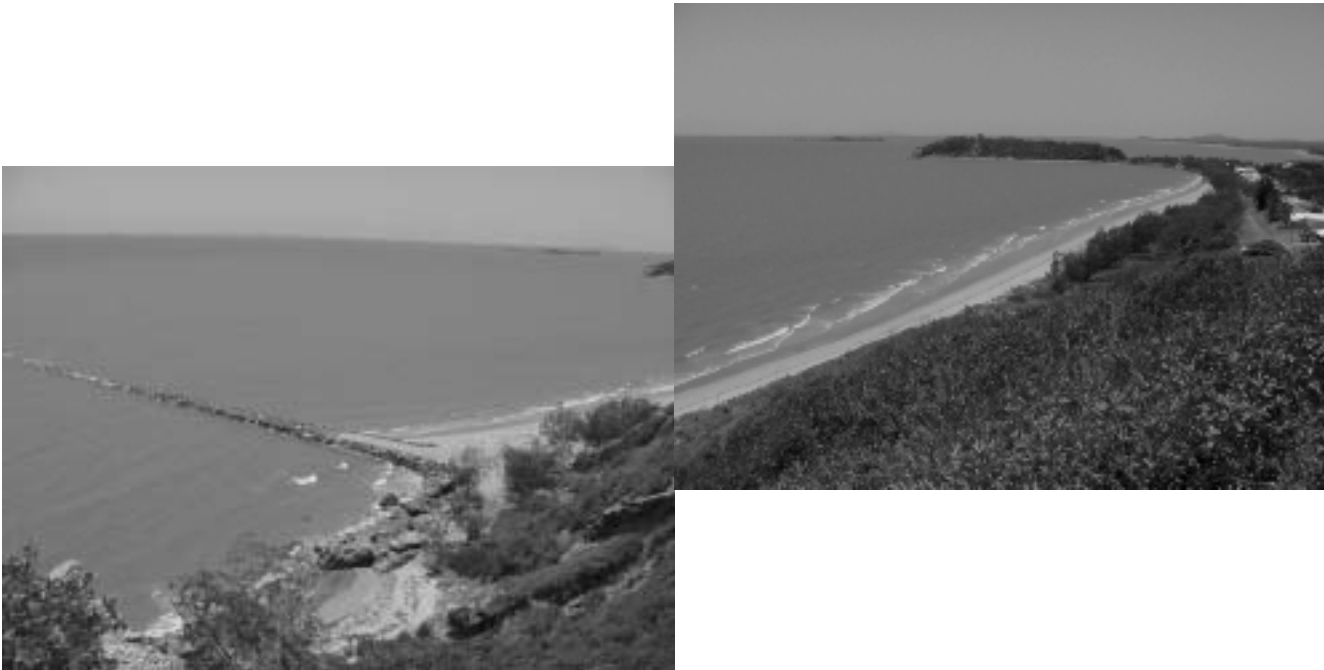
Figure 44. Extended groyne on Keppel Sands Beach, January 2002

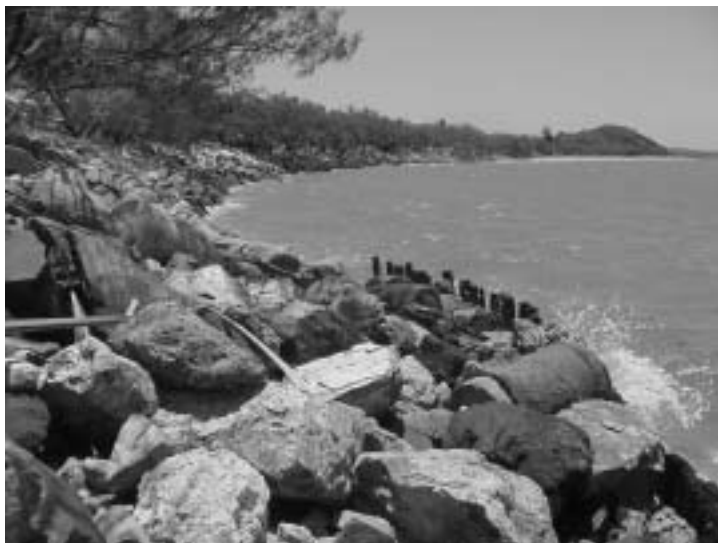
Figure 45. Keppel Sands, southern site of the beach. December 2001
