# Soil Factors Behind Inground Decay of Timber Poles: Testing and Interpretation of Results

**Abstract**—Inground decay is a major problem associated with the reliability and safety of timber poles. In modeling inground decay for effective maintenance strategies for timber poles, it is important to identify soil factors that are influential to the inground decay. This paper investigates some of the important influential soil factors and testing methods for those factors.

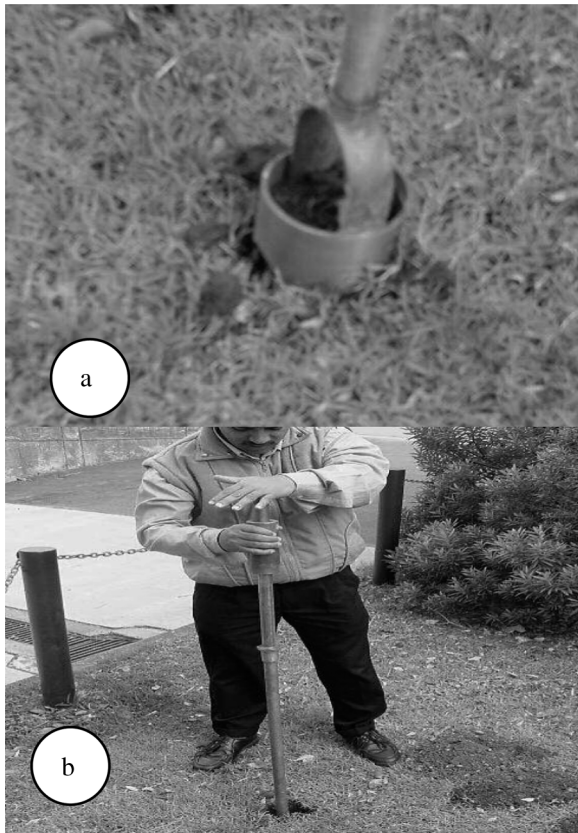
Fig. 2. Procedures for sample collection and measuring the depth of drill. (a). Drilling with the auger. (b) Sample extraction.

Samples were obtained by using a soil sampler tube (see Fig. 2 for sampling procedure) and immediately covering it with a layer of wax in order to protect it from the external interference [10]. As satisfactory storage to maintain natural properties of soil samples is difficult, it is recommended to inspect and test the samples at the sites or immediately after their arrival at the laboratory. But when the sample sites are far away from the testing laboratory or further studies are needed, then storage is essential. Each collected sample should have a label with a tag for identification, location of sampling, sampling date and type of soil.

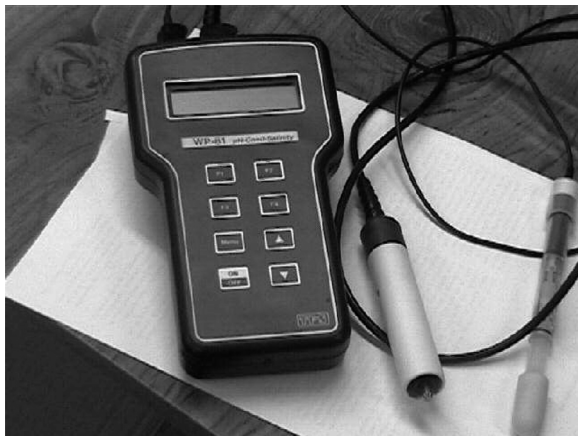
Fig. 3. WP 81-pH, salinity, and conductivity meter.

For pH value, conductivity and salinity of the sample testing: a WP 81-pH, salinity and conductivity meter TPS (Fig. 3) was used. Solutions were prepared by mixing one part by vol. of soil and five parts by volume of distilled water. pH of soil is measured by dipping the probe of the electronic pH tester into

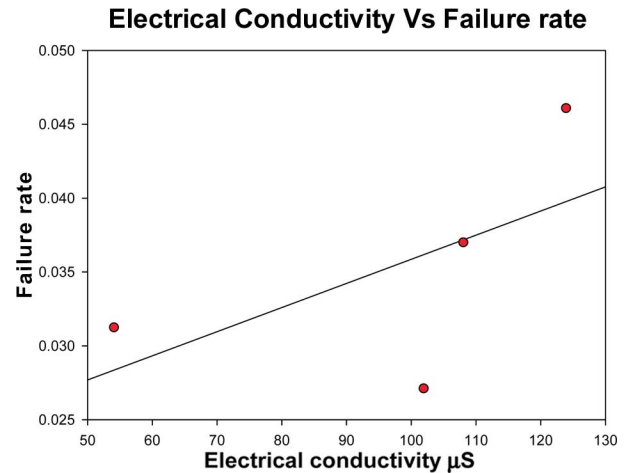
Fig. 9. Relationship model of electrical conductivity and timber pole failure rate.

that the failure rate of timber pole increases with the increase of electrical conductivity. The relationship model of electrical conductivity and timber pole failure rate can be seen in Fig. 9.

5) *Effect of Electrical Conductivity on the Failure/Decay*: The mean electrical conductivities of the collected samples are 101.91 μS in Chelmer, 54.07 μS in Holland park, 108.03 μS in Wynnum and 123.91 μS in Caboolture. From Fig. 9 it is seen

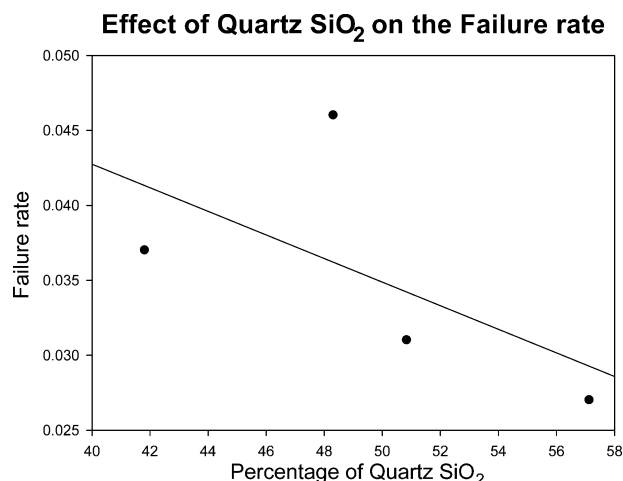
Fig. 10. Relationship model of quartz and timber pole failure rate.

The average percentage by weight of quartz against failure rate is analyzed in Fig. 10. This showed some relationship between failure rate of timber pole and the amount of quartz content. Failure rate decreases with the increase of quartz content of the surrounding soil. We know that the sandy soil. Because the high percentages of quartz content allows the soil to drain water and keeps the soil less moist. This helps in preventing the biological attack. This, in turn, allows a better decay condition of timber materials.
