# Retrofitting of Shear Damaged Reinforced Concrete Beams

T. G. Suntharavadivel

*School of Engineering & Built Environment, CQUniversity Australia, Rockhampton, Australia*

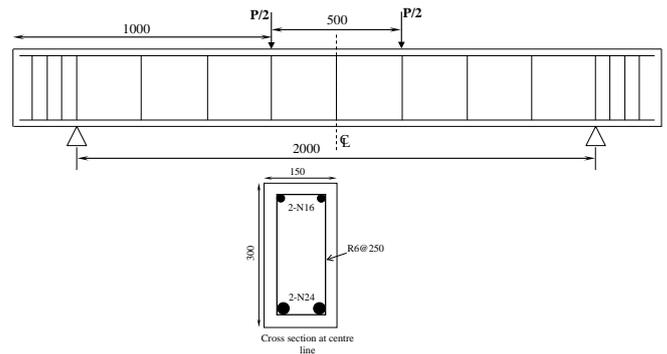
A total of 8 reinforced concrete beams were tested under four-point monotonically increasing load. All beams were designed with a rectangular cross section of  $300 \times 150$  mm and a length of 2.5 m. The span of the beams was set as 2.0 m. Reinforcement layout of the specimen is shown in Figure 1. The shear span of the specimens was kept as 750 mm as shown in the figure.

Figure 1. Typical reinforcement arrangement and dimensions of test specimens.

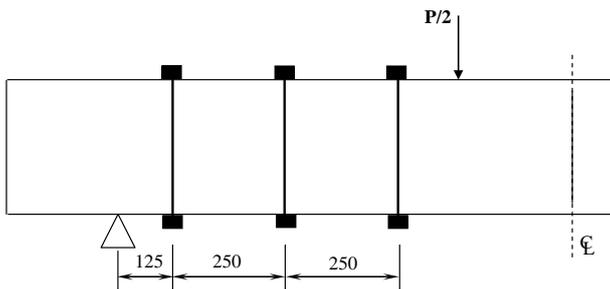
Specimens BEAM2, BEAM3, BEAM4 and BEAM5 were strengthened by vertical clamping as shown in Figure 2. Each external rod was tightened with a constant torque of 15 Nm. Specimens BEAM6 and BEAM7 were strengthened by inclined clamping as shown in Figure 3. The inclination of the rods was kept as  $45^\circ$  with the vertical and they were tightened with same torque of 15 Nm. The last specimen BEAM8 was strengthened with combined vertical and inclined clamping as shown in Figure 4. This arrangement was chosen to avoid local crushing of concrete due to 'wedge' action of the force near the loading point that occurred in the specimens with inclined clamping.

Figure 2. Arrangement for the external vertical clamping.

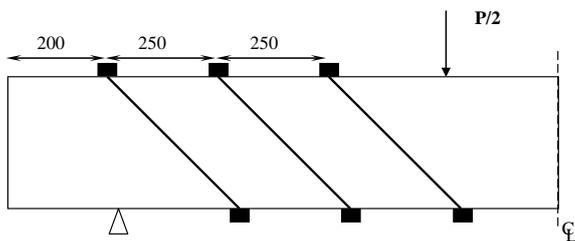
Figure 3. Arrangement for the external inclined clamping.

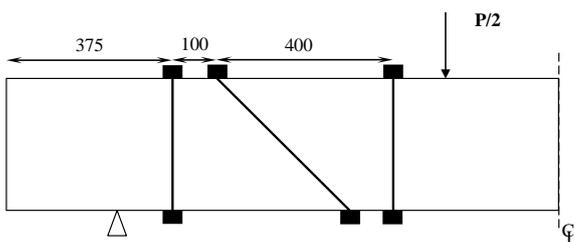
Figure 4. Arrangement for the combined external clamping.

From the failure of BEAM6 and BEAM7 it could be suggested that, even though the inclined clamping effectively controlled further opening of the crack in the beam, failure occurred near the loading point due to high stress concentration, which was further aggravated by the horizontal force component of the inclined clamping. Consequently, the last beam BEAM8 was strengthened with combined vertical

and inclined clamping as shown in Figure 4. With this arrangement, the stress concentration was reduced at the loading point and the support region. This specimen was loaded to 175 kN to generate initial crack and then strengthened by clamping. When it was reloaded specimen BEAM8 reached a load of 240 kN before failure.

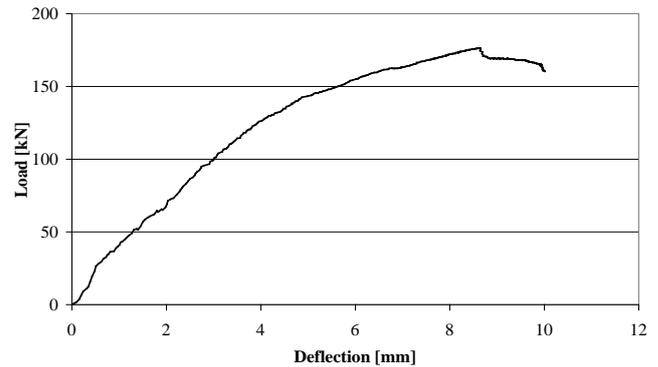
Control beam BEAM1 exhibited some flexural cracks at the bottom of mid span section at a load of about 100 kN. However, they did not appear to develop further with an increasing load. The first shear crack appeared at 110 kN and progressed with further loading. The control beam achieved 176 kN before it failed in shear. The load-deflection behaviour of this control beam is shown in Figure 5. Except for the initial seating error, the behaviour of the control beam was linear until about 120 kN. The formation of shear cracks reduced its stiffness, which is indicated in the figure at a load of about 120 kN. The maximum crack width at failure was about 6 mm. The failure mode of the control beam is shown in Figure 6.

Figure 5. Load-Deflection behaviour of control specimen BEAM1.

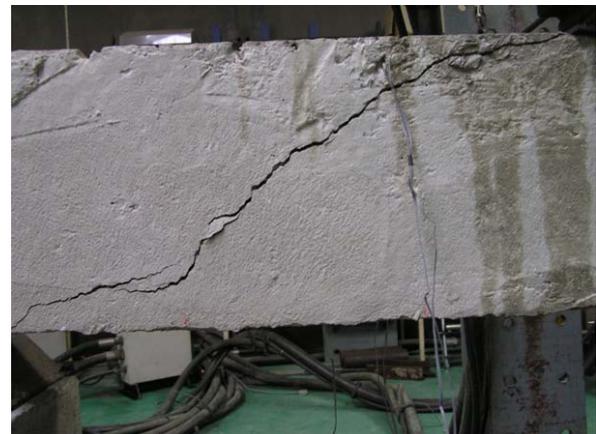
Figure 6. Failure of control beam BEAM1.

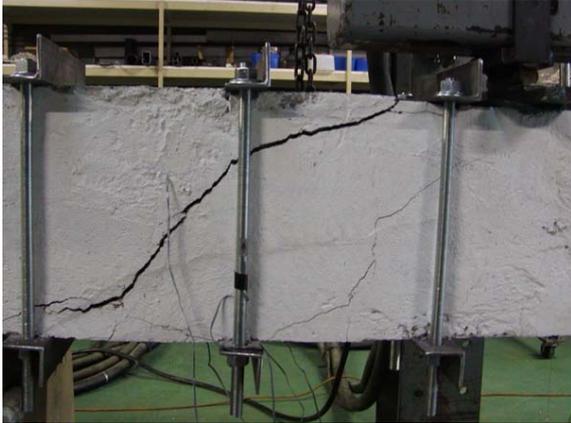
specimen. The formation of cracks and beam's performance were similar to those of control beam BEAM1. The load was released and beam was strengthened by vertical clamping. Then the specimen was reloaded until failure. It was noted that the original crack reopened during the reloading process and some local shear cracks also developed between the vertical clamping as shown in Figure 7. The specimen later failed at a load of 262 kN. The maximum crack width of 11 mm was observed at failure.

Figure 7. Failure of specimen BEAM2.

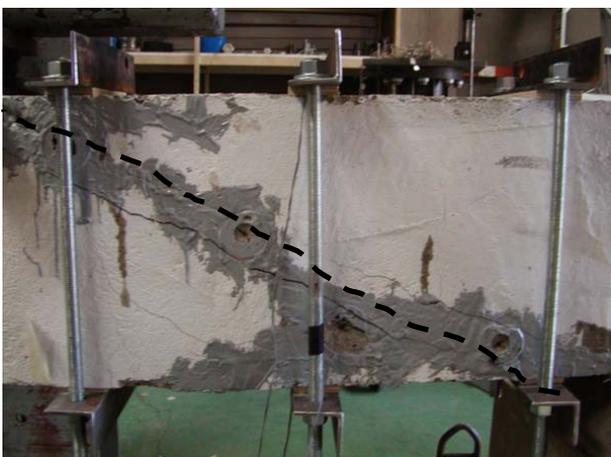
Specimen BEAM3 was loaded the same way as BEAM2 and the initial crack generated. The behaviour of BEAM3 was observed to be similar to that of specimen BEAM2. The cracks were repaired with epoxy injection and allowed for a week to cure the resin and to develop a good bond. Then the specimen was externally clamped, similar to BEAM2, and reloaded. A completely new shear crack developed and led to failure of this beam as shown in Figure 8. The repaired crack did not open up during the whole reloading process. This suggested that the epoxy resin repair is an efficient repair technique which significantly reduces the effect of existing shear cracks. Furthermore, it also increased the capacity of the member to 279 kN which is 18 kN higher than specimen BEAM2.

Figure 8. Failure of specimen BEAM3 (initial crack is highlighted).

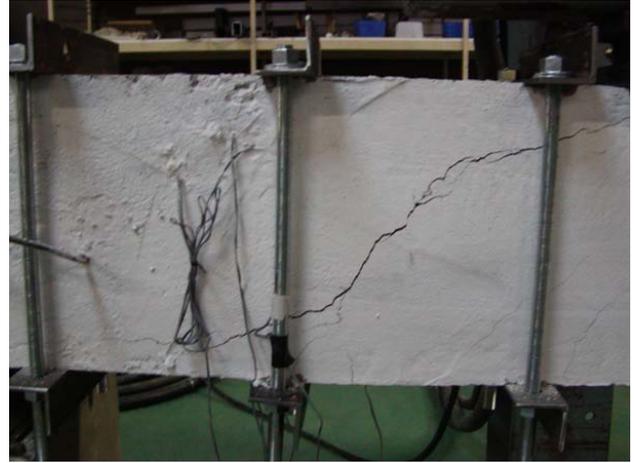
The specimen BEAM4 was initially strengthened by vertical clamping and loaded until failure. Same clamping force was applied using 15 Nm torque as other specimens with vertical clamping. This uncracked reinforced concrete beam with vertical clamping failed at a load of 287 kN. The major shear crack and local shear cracks were observed to be similar to those of BEAM3 (see Fig. 9).

Figure 9. Failure of specimen BEAM4.

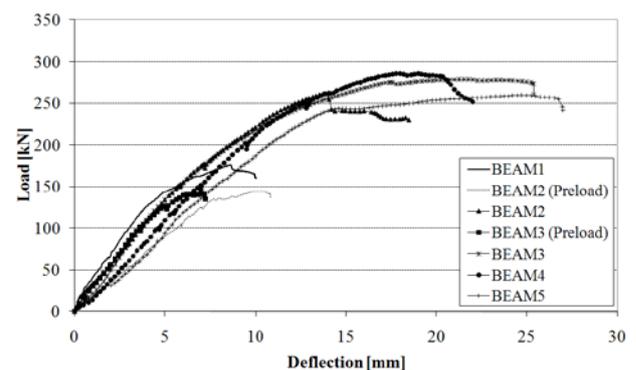
The load-deflection behaviour of specimens BEAM1, BEAM2, BEAM3, BEAM4 and BEAM5 are shown in Figure 10. From the graph, it can be noted that the response of all specimen was similar during the preloading stage. After strengthening, specimen BEAM3 showed more ductile behaviour than BEAM2 and the behaviours of BEAM3 and BEAM4 were very similar. This implies that the epoxy repair could improve the behaviour of a cracked specimen back to a new specimen.

Figure 10. Load-Deflection behaviour of specimens with vertical clamping.

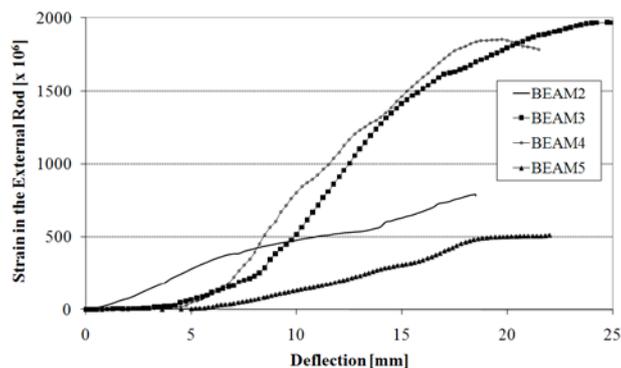
The effect of the external clamping and the epoxy injection can also be seen from the strain variation in the external clamping rod as shown in Figure 11. It can be noted that, in the beam BEAM4, there is no significant strain increase at the external clamping rods until the load reaches about 110 kN, which corresponds to the load at which major shear crack developed in that specimen. This means that, until the formation of a major shear crack, the contribution of the external clamping in carrying the shear force was insignificant. Beyond the load of 110 kN, the strain in the external clamping increased gradually with the load increase indicating that the external clamping contributed to taking additional load. As the crack width increased with the loading, the stress transferred through the concrete, which is mostly by aggregate interlocking, decreased. Due to this process, a gradual increment in the force on the external clamping was observed in the strain readings.

The variation of strain in the external clamping rods of beams BEAM3 and BEAM5 (repaired with epoxy injection) were similar to that of BEAM4. However, the behaviour observed in specimen BEAM2, which was not repaired with epoxy injection, was quite different from the other 3 specimens. From the strain measurements, it was noted that the force in the external rods increased right from the beginning of the reloading in specimen BEAM2. This implies that the concrete did not contribute much towards carrying the shear loads. From this observation, it can be deduced that the epoxy repair significantly changed the behaviour of the cracked beams.

Figure 11. Variation of strain in the external clamping rod.

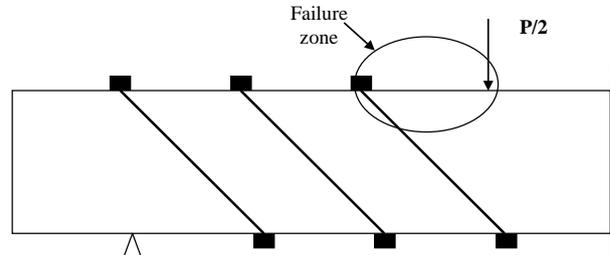
the reloading process. However, the width of the crack was much less than BEAM2 (with vertical clamping) for same load. The inclined clamping restricted the crack opening compared to vertical clamping. Even though the inclined clamping effectively restricted the crack from opening, the specimen failed at a load of 214 kN due to premature crushing of concrete near the loading point (Figs. 12-13). The maximum crack width of 8 mm was observed at failure.

Fig. 12. Failure zone of specimens BEAM6 and BEAM7.

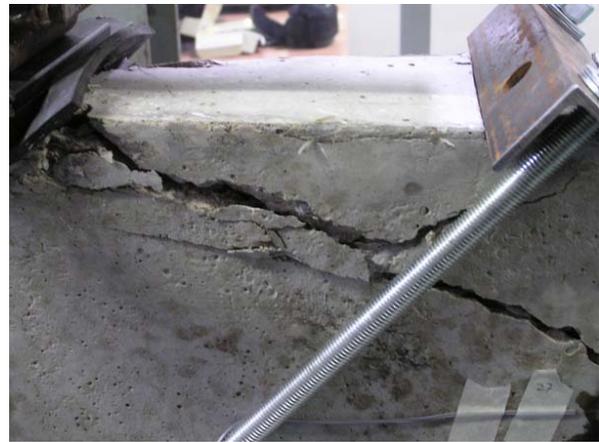
Figure 13 Localised concrete failure near loading point of specimens BEAM6 and BEAM7.

Specimen BEAM7 was loaded the same way as BEAM6 and a similar progress applied for initial crack generation. After epoxy repair and curing, the specimen was externally clamped (similar to BEAM6), and reloaded. A completely new shear crack was observed and that led to failure of the beam. The repaired crack did not open up during the reloading process. This again proves that the epoxy resin repair is an efficient repair technique and significantly reduces the effect of existing shear cracks. Furthermore, it increased the capacity of the member to 233 kN from 214 kN when the crack was unrepaired. However, the beam also failed due to the concrete crushing near the loading point, similar to BEAM6. At the maximum load, the crack width was 4 mm and it increased to 7 mm at failure.

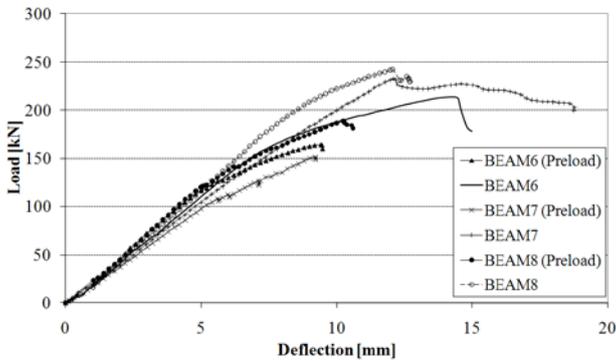
Figure 14. Load–Deflection behaviour of specimens BEAM6, BEAM7 and BEAM8.

The load-deflection behaviours of specimens BEAM6, BEAM7 and BEAM8 are shown in Figure 14. Although the effect of inclined clamping could not be observed very clearly due to the localised concrete failure near the loading point, from the graph it can be noted that the epoxy repaired specimen exhibited better behaviour and carried significantly higher load than the un-repaired specimen. As discussed earlier, the inclined clamping successfully controlled the crack width during loading. However, due to the premature failure, the effectiveness of the inclined clamping could not be investigated in detail. Therefore, further investigation is necessary to explain the effectiveness of the inclined clamping technique. The test results are summarised in Table 2.
